RE: Archaeological Testing, Albert Gallatin Jenkins House at Green Bottom, Cabell County, West Virginia

CRA Report: WV02-64

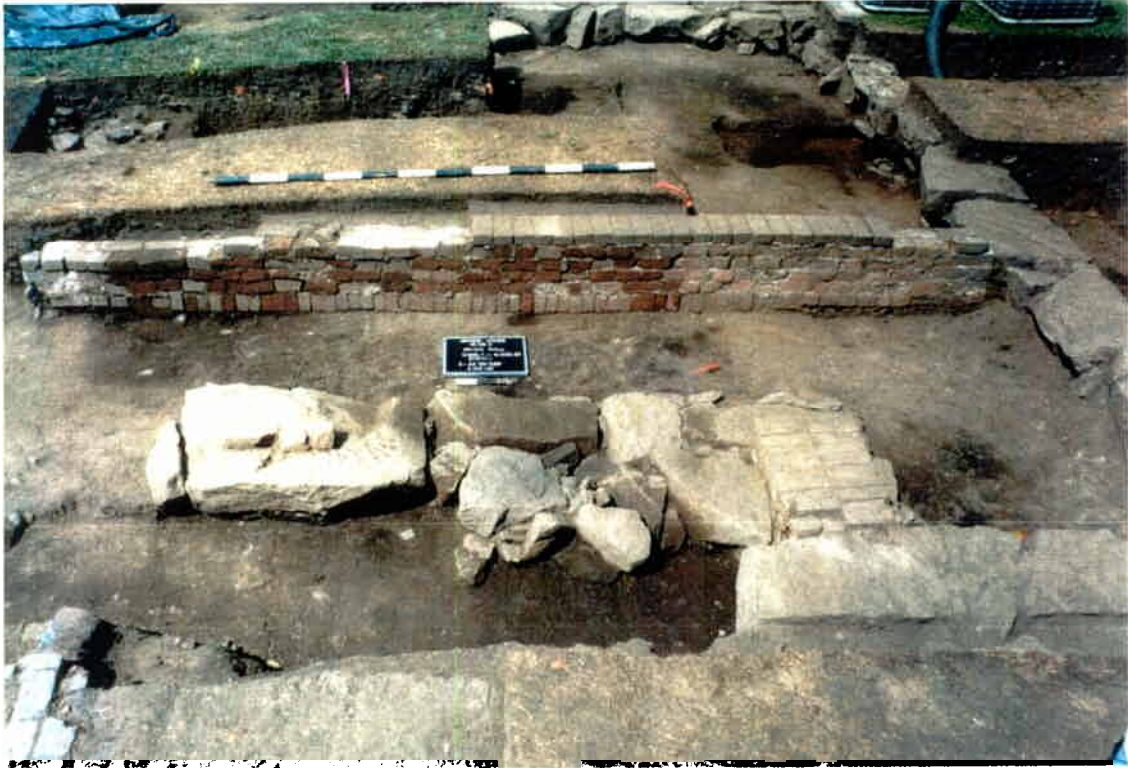
Figure 2: Photograph showing excavation of kitchen area.

100 square meters (1076 square feet) in this area of the site (Figure 2). A 6.06 meter (20 feet) long and 6.66 meter (22 feet) wide partial stone foundation was documented. Only portions of the east and west walls and the north wall were intact. Southern portions of the east and west walls and the entire south wall had been removed, with the materials probably being re-used in the construction of the garage in the 1930s. A 2.42 meter (8 feet) long stone hearth was documented along the eastern wall of the structure. A brick wall was located 2.50 meters (8.25 feet) from the eastern stone wall. It appears that the brick wall was a later addition to the structure, perhaps becoming the eastern wall of the structure some time after the American Civil War. A possible brick porch was encountered on the southeast corner of the structure suggesting a possible door location. Immediately south of this feature was a ash filled pit, suggestive of a location for dumping stove or fire-place cleanings. Surrounding the structure were a number of shallow post holes suggestive of the supports for scaffolding used during the construction of the building. A cursory examination of artifacts identified ceramics, container glass, eating utensils, animal bone, and personal items. This suggests the structure was used as a kitchen, and was contemporaneous with the construction of the Jenkins House. The presence of early 20<sup>th</sup> century artifacts cooberates the oral tradition that the structure was destroyed during the 1913 flood. A portion of the kitchen appears in a ca. 1906 photograph as the northernmost structure of the two shown in the photograph.

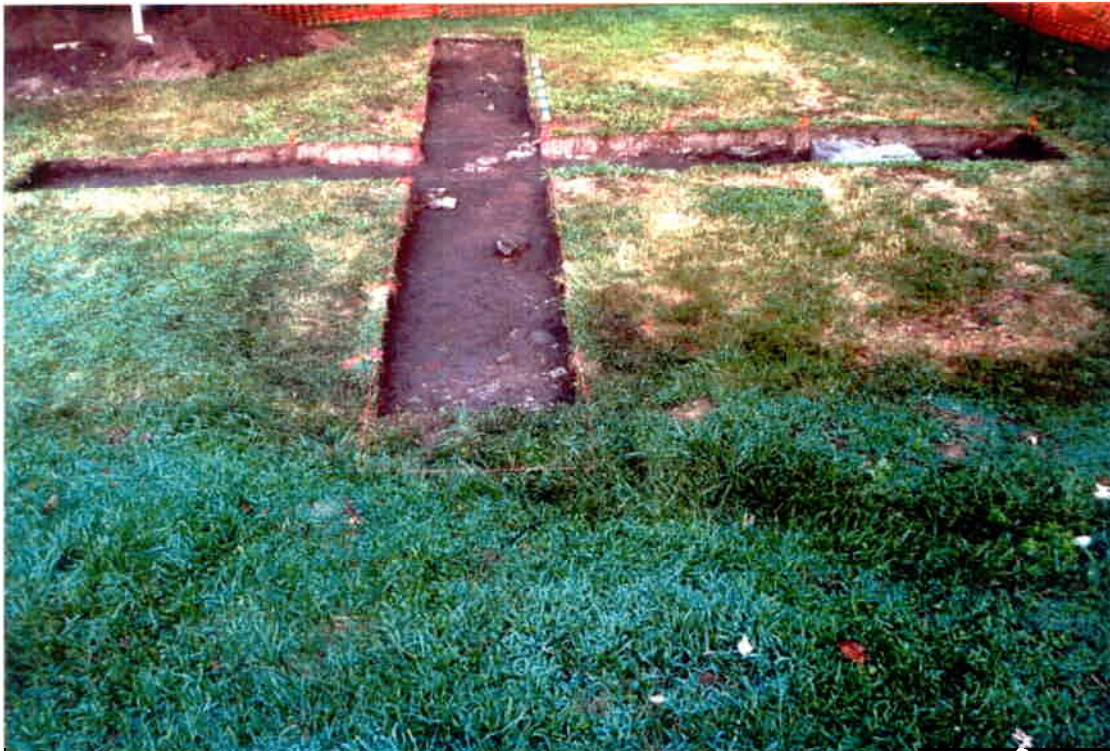
Figure 3: Photograph showing excavation of “law” office.

The “Law” Office Area is located approximately 3.6 meters (11.88 feet) southwest of the main Jenkins House structure. Excavations in this area were based on the presence of a shallowly buried foundation located by probing and differential patterns in the growth/health of the grass. The excavation consisted of a cruciform trench that crossed the structure’s walls in the cardinal directions (Figure 3). Evidence of a stone wall and robbed trenches was discovered. Extant evidence indicates that the structure at this location was 6.06 meters (20 feet) long, and 6.06 meters (20 feet) wide. An intact stone foundation with the remains of a possible entrance step was located along the north wall. The south, east, and west walls were marked by shallow rubble and mortar filled trenches. The stones from these areas appear to have

been robbed, and were likely used in the construction of the patio. Few artifacts were recovered from this area, with most collected dating from the mid-19<sup>th</sup> century. It has been suggested that General Jenkins constructed a “law” office building ca. 1850. To date, this is the best candidate for that structure, although its function as a “law” office cannot be supported on the basis of extant information.

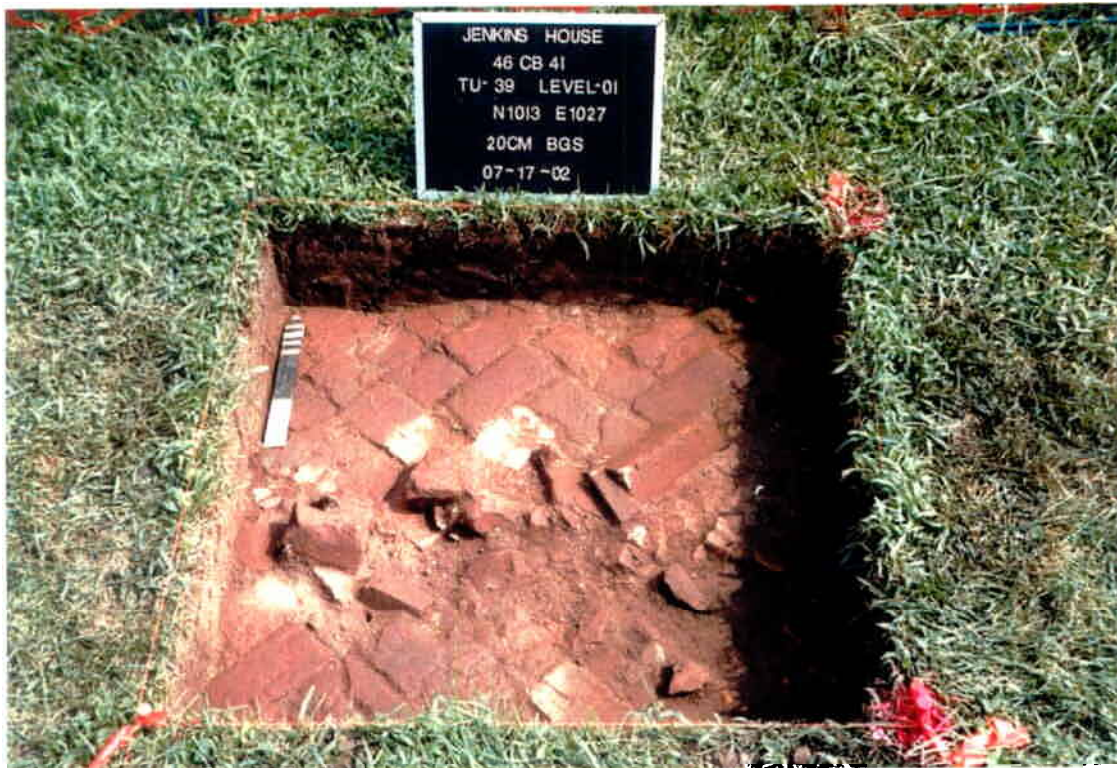
Figure 4: Photograph showing herringbone sidewalk.

Immediately south of the rear door of the Jenkins House and the concrete sidewalk leading to it, were the remains of a brick “herringbone” sidewalk (Figure 4). The sidewalk leads from the rear of the house south to the privy.

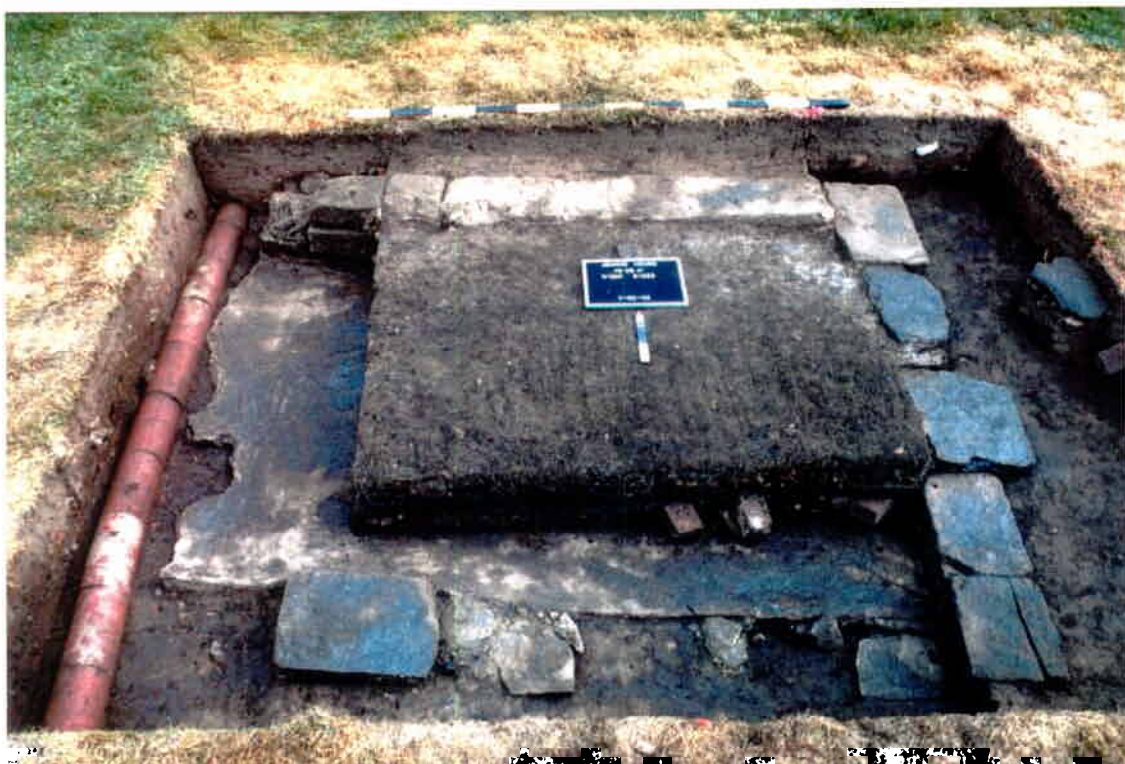
Figure 5: Photograph of privy.

A 3.03 meter (10 feet) long and 2.42 meter (8 feet) wide stone lined privy was located 14 meters (46.2 feet) south of the Jenkins House. This privy was approximately 40 centimeters (15.7 inches) deep and lined on the sides and bottom with mortar (Figure 5). The fill appears to represent debris from the destruction of the privy structure and coal cinders. Shallow privies were designed to be frequently maintained, and were not allowed to become over-filled with human waste.

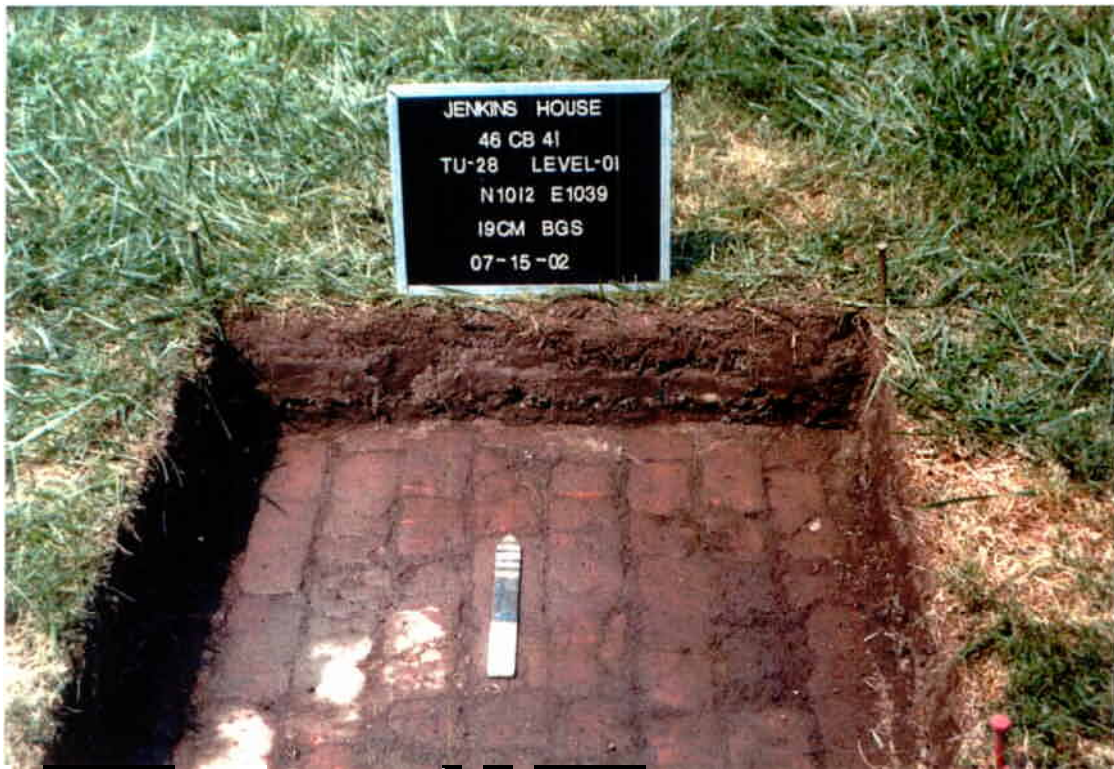
Figure 6: Photograph of running bond brick sidewalk.

Leading from the area between the Jenkins House and the Kitchen was a second brick sidewalk. This walkway was formed by bricks laid in a running bond pattern (Figure 6), and abruptly terminated approximately 5 meters (16.5 feet) from the extant concrete driveway. On either side of the sidewalk were two square 19<sup>th</sup> century postholes suggestive of a gate (Figure 7).

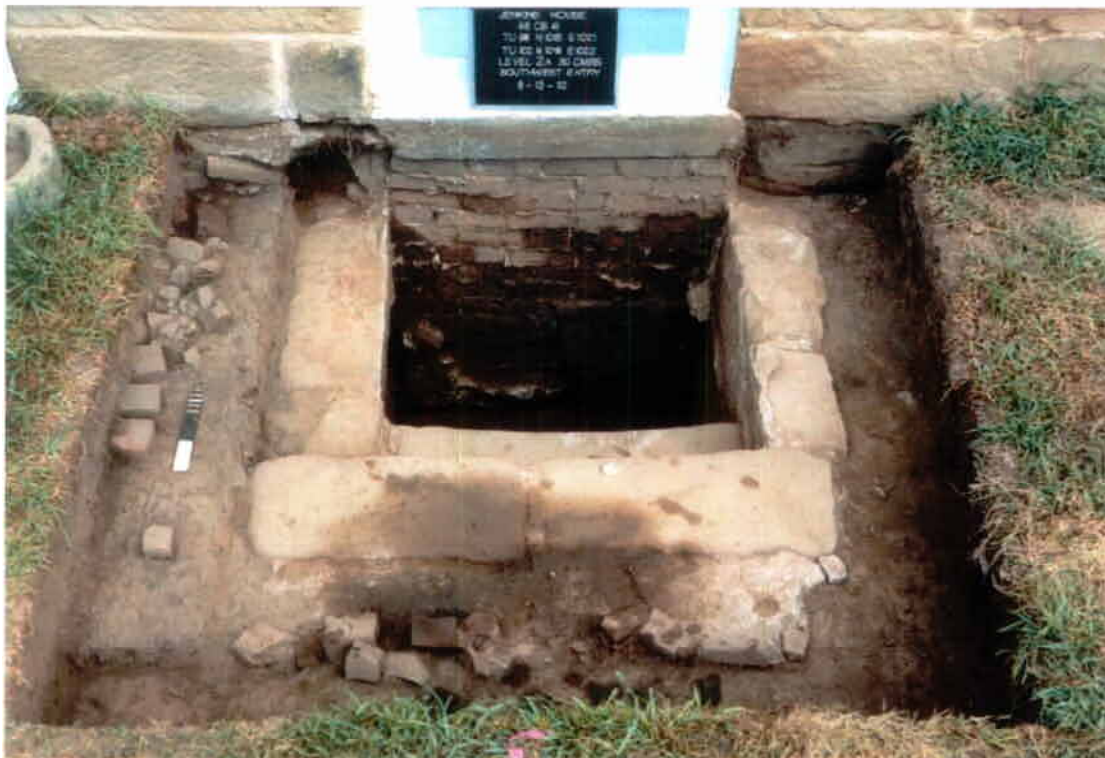
Figure 8: Photograph showing former southwest entry into basement of house.

A window on the southwest corner of the Jenkins House marks the location of a former door into the first floor (basement) of the house. The former entryway consisted of a set of stone steps leading down to a bricked-up opening that was originally approximately 1.81 meters (6 feet) in height (Figure 8). Artifacts from this area suggest it was filled in the 1930s when other modifications to the house were occurring.

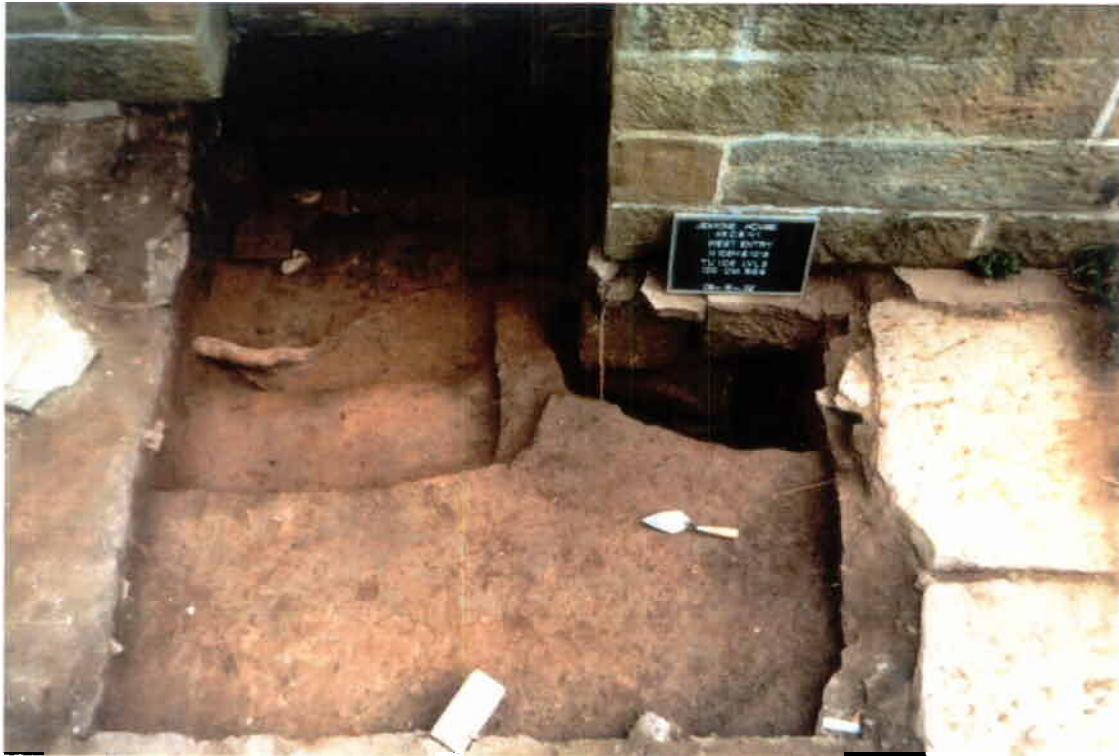
Figure 9: Photograph showing former opening on west side of house.

A bricked-up opening on the western side of the house was also examined. This was also found to have been a 1.81 meter (6 feet) tall opening into the first floor (basement) of the house. The stones from this opening had been removed, leaving clay and artifact filled features at their former locations (Figure 9). A portion of the patio removed in this area, resulted in the identification of prehistoric midden directly beneath the patio stones. This suggests that a building had not been placed in this location during the 19<sup>th</sup> century.

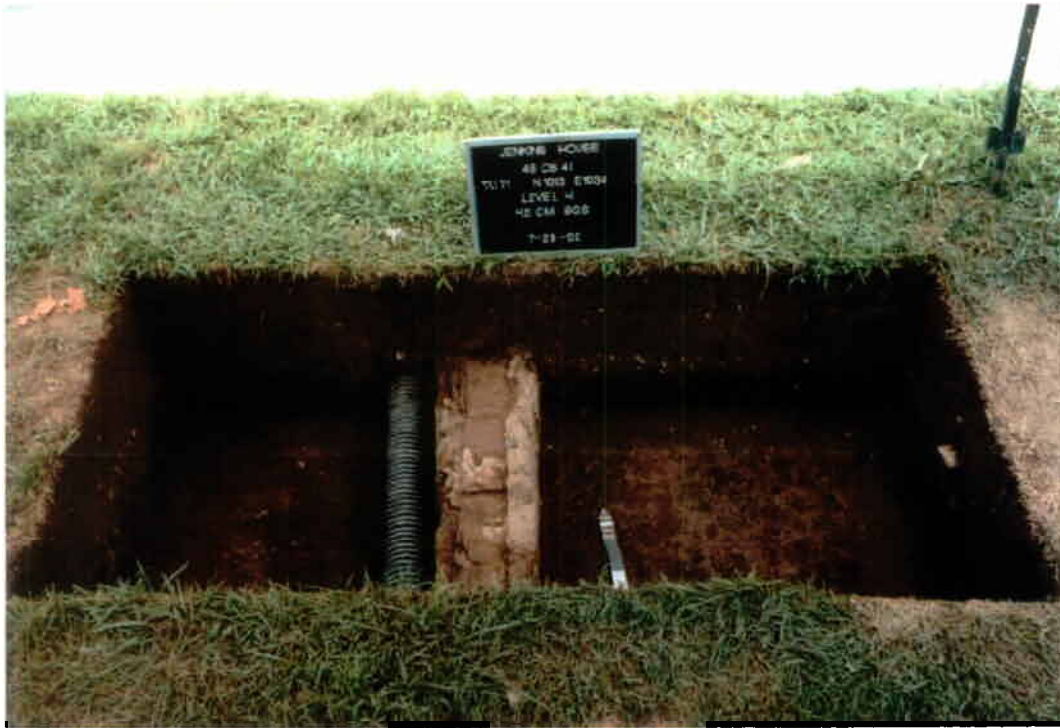
Figure 10: Photograph showing U shaped brick drain feature.

A “U” shaped drain or open trough constructed of brick was encountered 6 meters (19.8 feet) from the southeastern corner of the Jenkins House (Figure 10). This feature appears to be a portion of a drainage system designed to carry rainwater away from the house.
